Manhole Inspection Summary

Manhole # S35A1_007MH

Insp Date: **8/18/08 10:43 AM**

Location Address: **150 w dickman st**

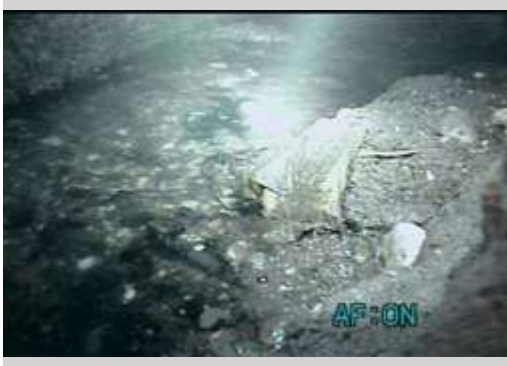
Defect 3

Condition: ☐ Sound ☐ Cracked ☐ Root Intrusion ☐ Deteriorated ☐ Leaks ☒ **Debris**

channel debris

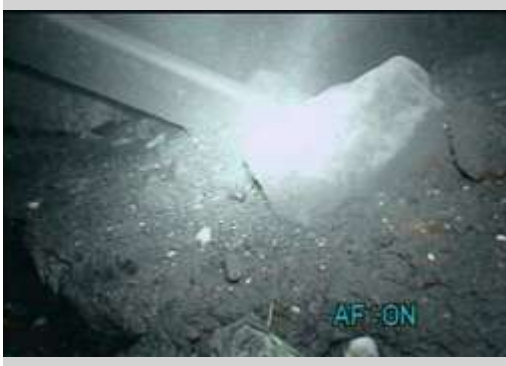
Defect 2

Condition: ☐ Sound ☐ Cracked ☐ Root Intrusion ☐ Deteriorated ☐ Leaks ☒ **Debris**

bench debris

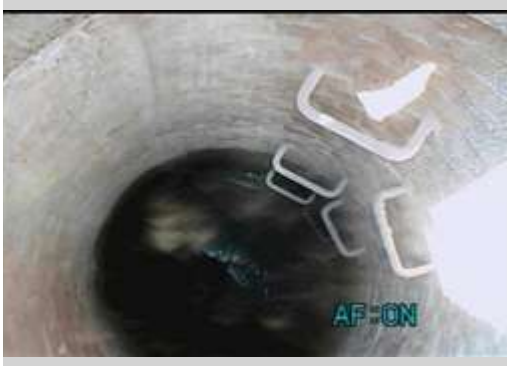
Defect 1

Steps Count: **8** Missing: **0** ☒ **Corroded**

steps

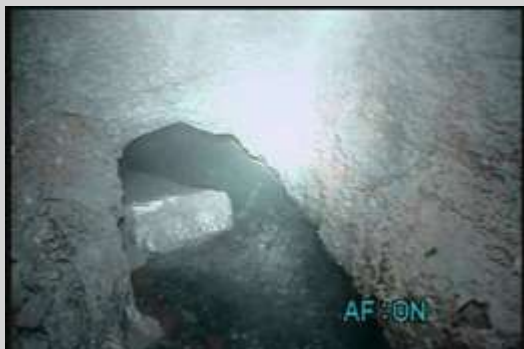
6 O'Clock Inflow

15 in. Circular Gravity Sewer
Pipe In @ 6 O'Clock

Deposits: ☐ None ☐ Mud ☐ Sludge ☒ **Debris** ☐ Grease

Silt Depth: 6 (in.) Deposits Extent: **Medium**
